National Property Inspections

SAMPLE COMMERCIAL, 1234 Any Street, Anycity, US, 99999

Thursday, May 18, 2017

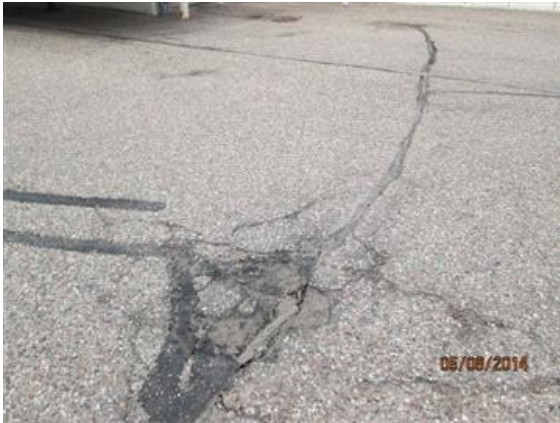
Parking lot needs to be inspected and maintained routinely as there are large cracks, (previously filled), that have reopened. Consider sealcoating of the lot after cracks have been repaired and filled.

Parking lot cracks

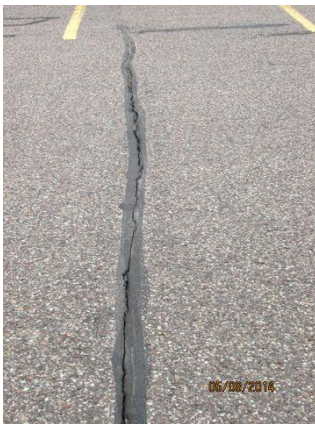
Larger crack on the east side drive area.

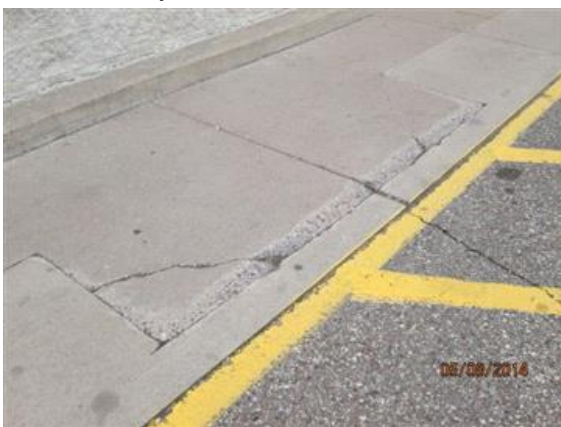
Sidewalk area that has been ground down to eliminate a tripping hazard.

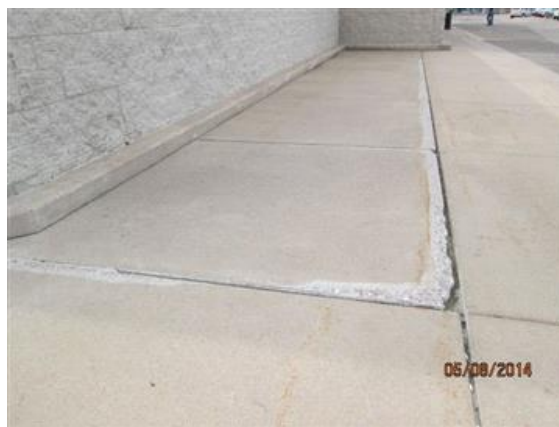
The sidewalk on the east side of the building has separated from the foundation by 1.5". There is evidence of settlement of the concrete flatwork as uplifted sections and corners have been "ground" down to eliminate tripping hazards and try to make them more level. Make repairs as needed and continue to monitor for movement.

Sidewalk at front of store showing signs of settlement. Has edges ground down.

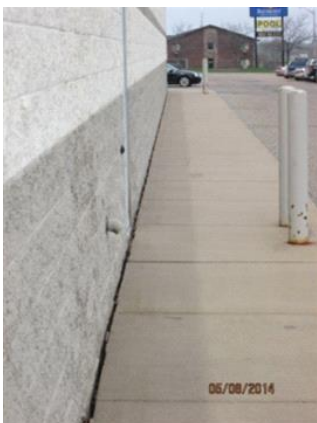
East side of building showing opening at foundation.

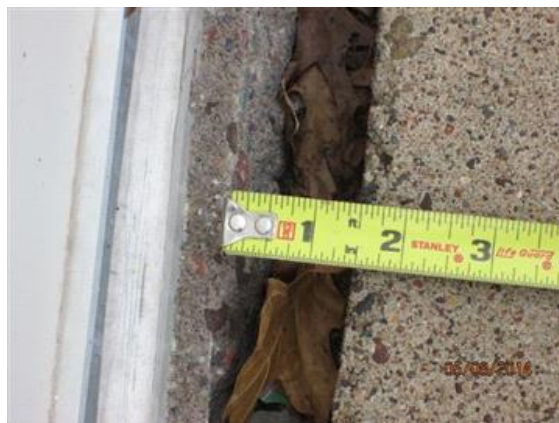
Sidewalk has pulled away 1.5" on the east side of the building.

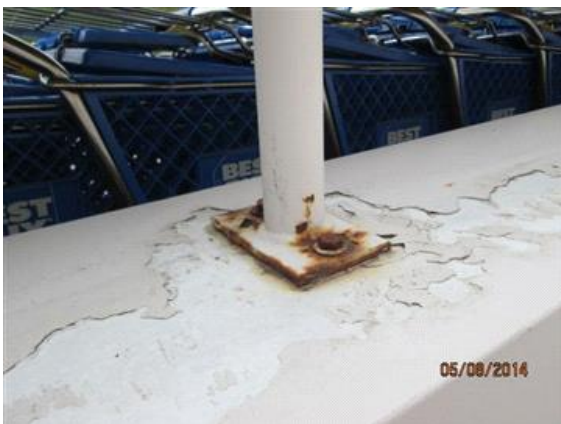
Dock area retaining wall top cap is damaged in at least three places and water can get in under the cap. The railing anchor bolts on this wall are rusting and are at risk of failing.

Rusted bolted connection of railing on top of loading dock wall.

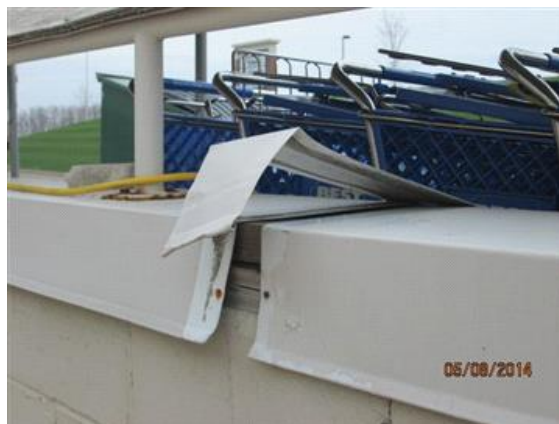
Top cap is damaged on the loading dock retaining wall.

Repair grass areas that have died due to "drive over" at curb as well as repair retaining wall top cap where damaged.

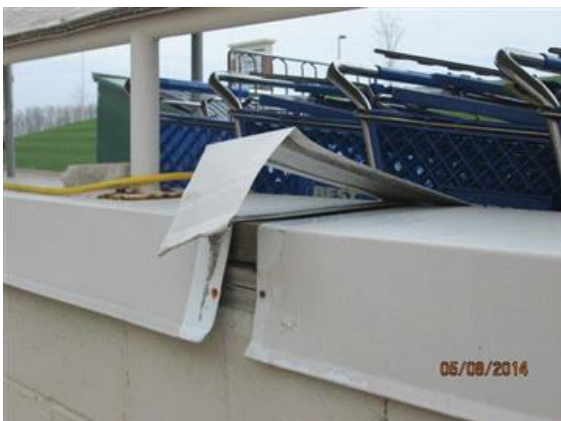
Top cap is damaged on the loading dock retaining wall.

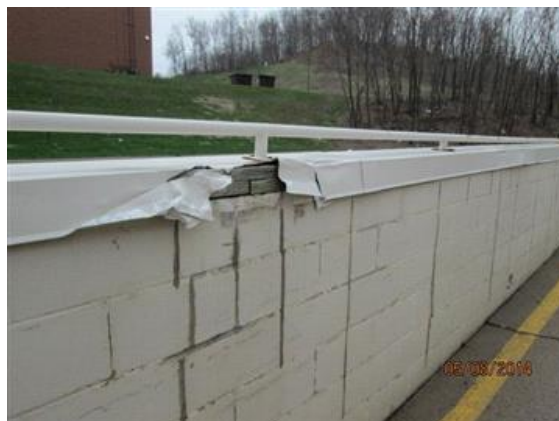
Retaining wall damaged top cap and block mortar joints in need of painting.

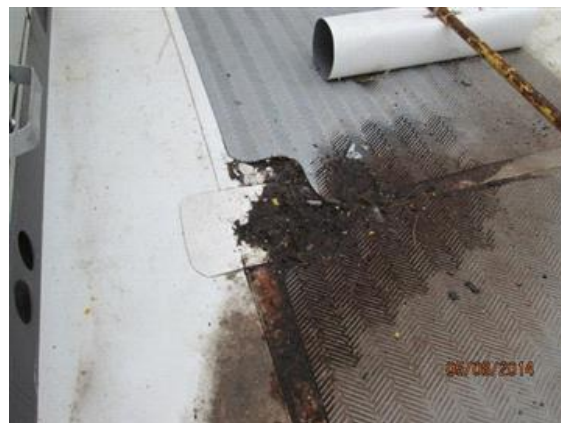
The roof was replaced last summer and a membrane roof was installed. Some small areas of ponding as evidenced by settled and dried dirt areas were seen. In a few locations where water and dirt have puddled on the roof, ensure that no seams are open to create any leaking.

Dirt has settled in the ponding area.

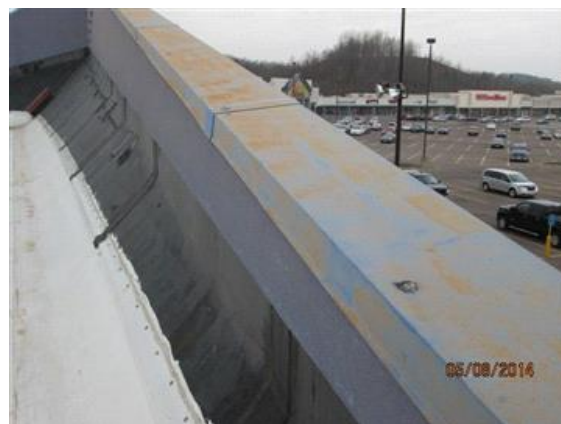
North side galvanized top cap flashing that is showing signs of rust.

The parapet wall was in good condition with the exception of the top cap at the front of the building which is showing signs of rust.

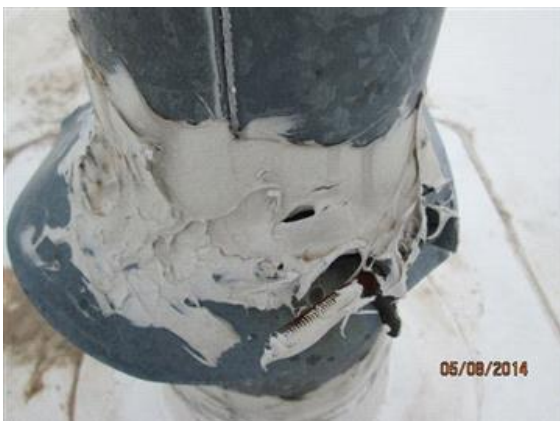
Open hole in caulking at vent pipe.

Repair open caulk joint on vent pipe that had been previously caulked.

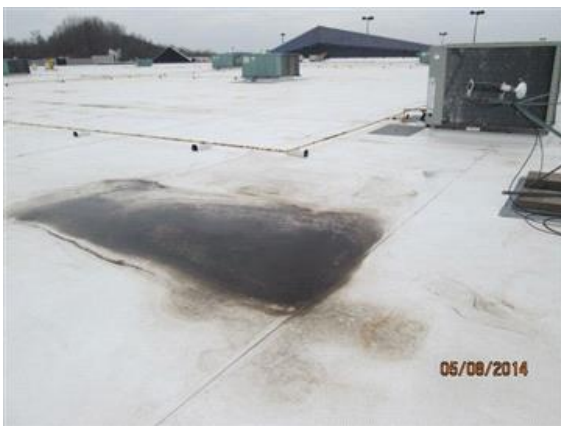
Area of ponding on the roof.

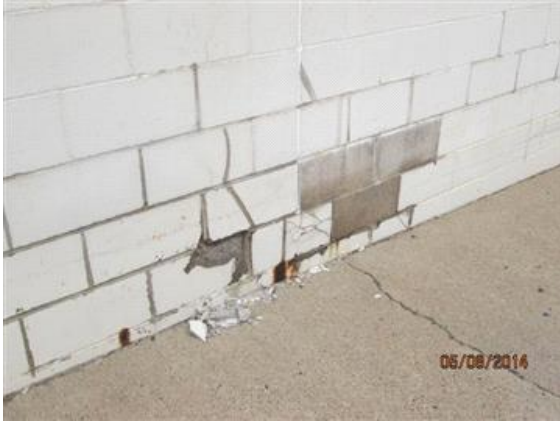
Deteriorated concrete block face.

The decorative concrete block at the north and east sides of the building have some areas of cracking due to settling. Seal cracks and make repairs as necessary and monitor for any further movement. Where block mortar joints have cracked and been filled, the repairs are very visible and the wall is in need of painting.

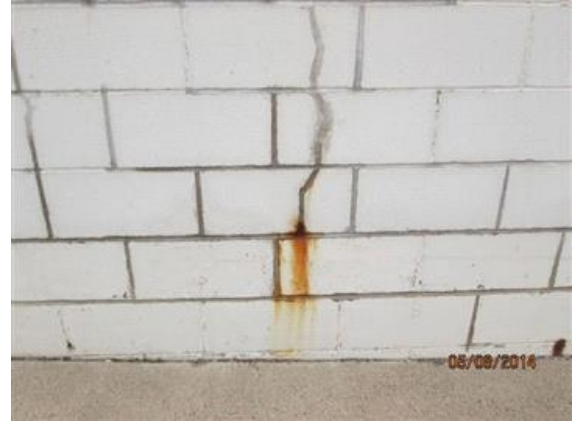
Concrete block vertical crack with rust.

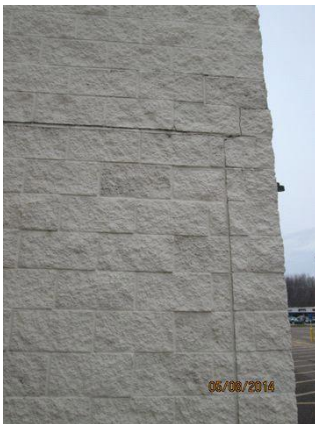
Vertical crack in concrete block at corner.

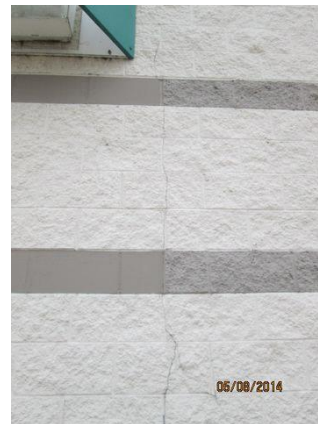
Vertical crack in wall.

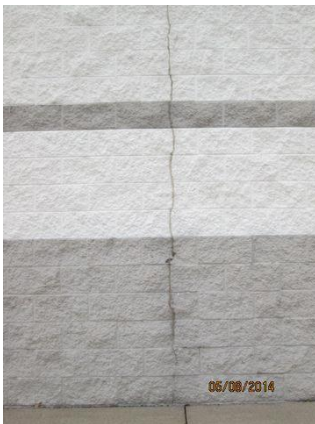
Vertical crack in wall.

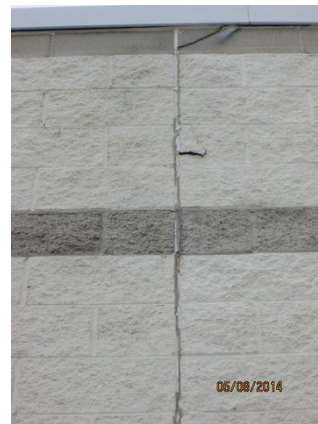
Vertical crack in wall extending all the way to the top of the parapet wall where the block has broken.

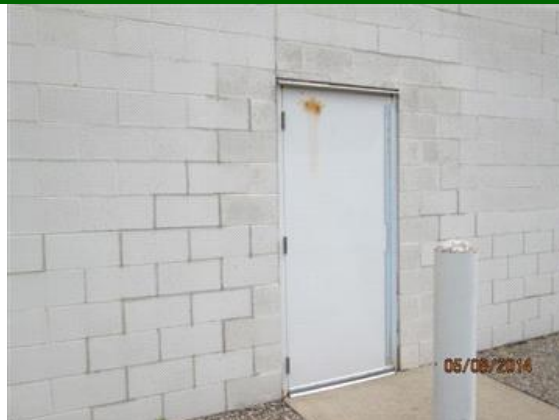
The main doors and service doors are in good condition. There are a few signs of rust on the hollow metal exterior service doors that will need some maintenance.

Exterior service door - note spot of rust at top of door.

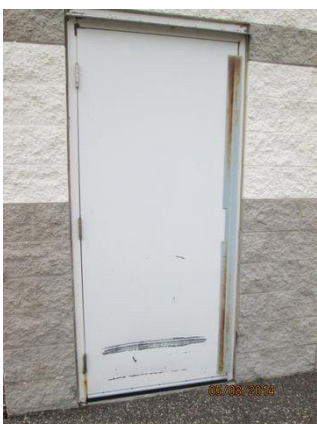
Service door with scratch in the bottom of door and a small spot of rust at base of frame.

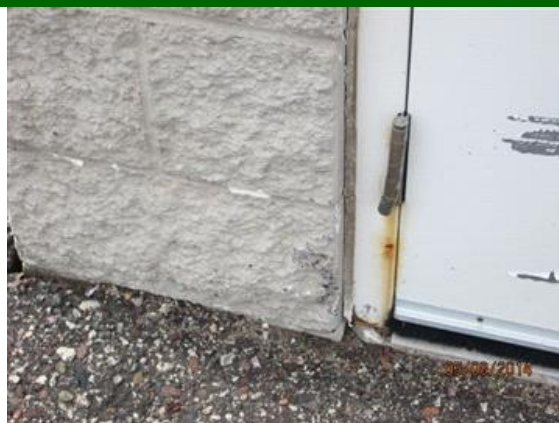
Rust at bottom of service door.

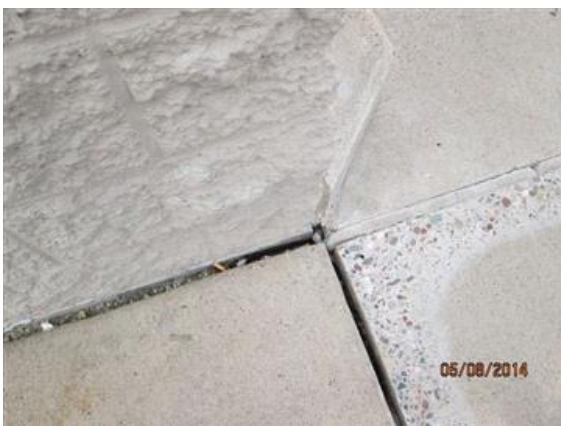
Movement of sidewalks at foundation.

Along the base of the foundation where the sidewalk areas come into contact with the exterior walls, there is the need to reseal these joints. They have been filled in the past but have opened up again.

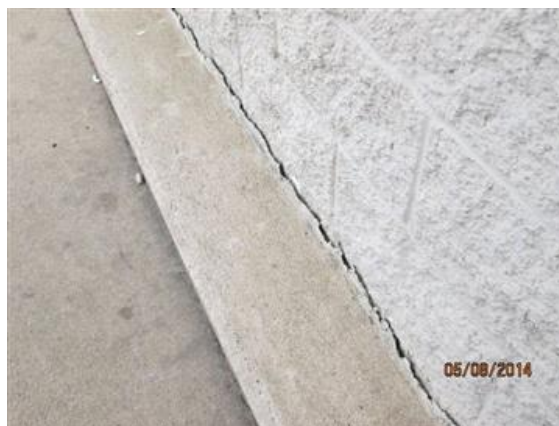
Open joint at foundation wall.

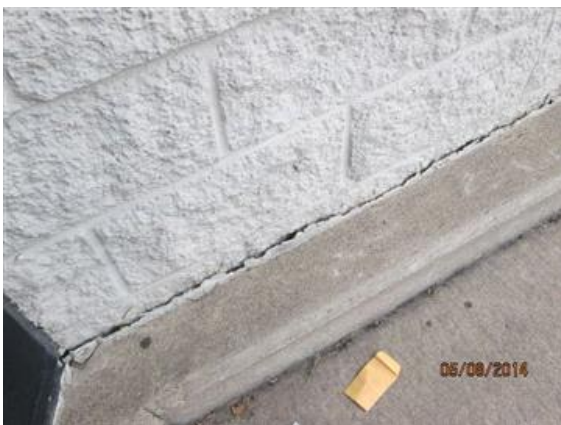
Open joint at foundation wall.

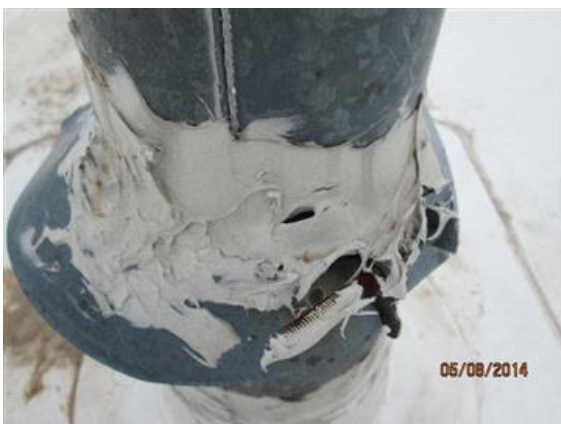
Open hole in caulking at vent pipe.
