National Property Inspections

SAMPLE COMMERCIAL, 1234 Any Street, Anycity, US, 99999

Thursday, May 18, 2017

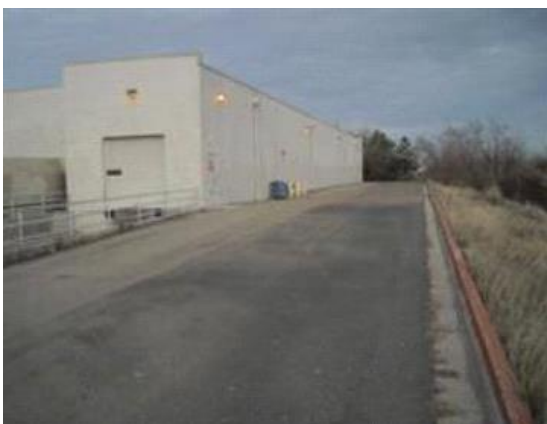
South side of property. Adjacent property is at a higher elevation.

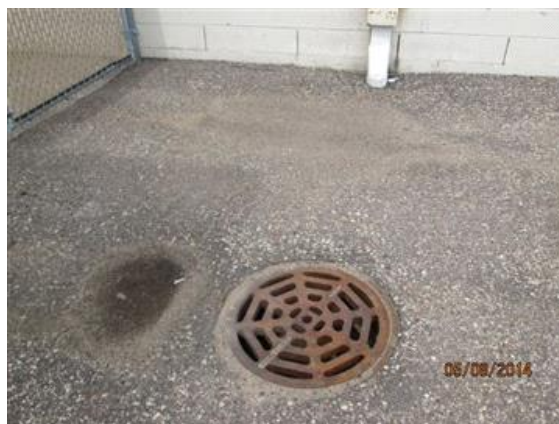
Catch basins on the property take rainwater from the roof through downspouts and underground into the catch basins.

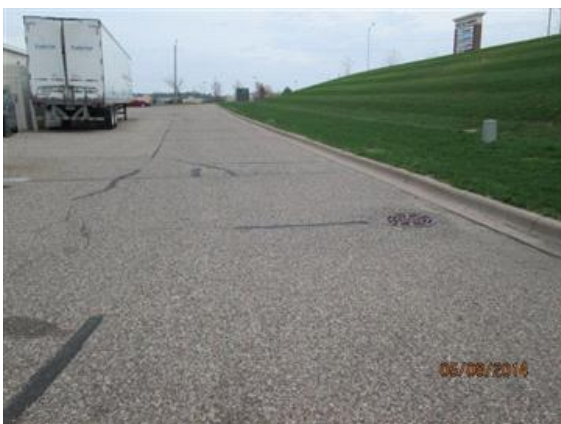
South side of property. Adjacent property is at a higher elevation.

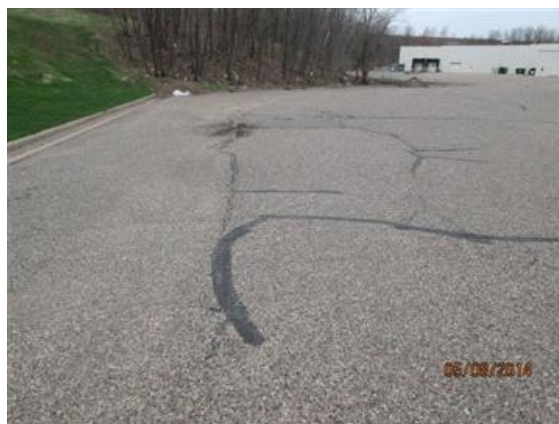
South side of property slopes to the west to a drainage area and catch basins.

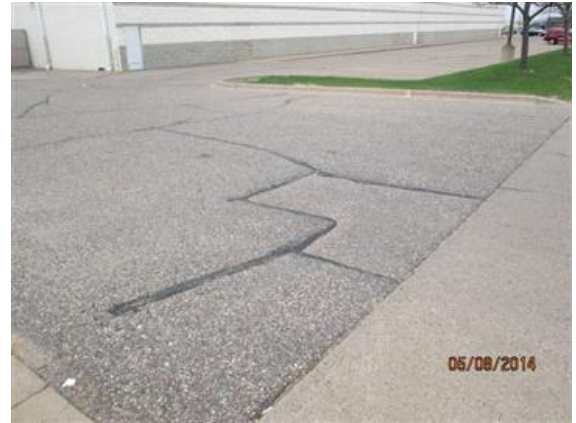
The driveway and parking areas for this property are part of a larger development and all of the parking and driveway areas are in a similar condition. Settlement has occurred and the asphalt, although patched in the past, will need routine maintenance to remain viable.

Entrance to driveway area at the southeast corner.

Parking lot needs to be inspected and maintained routinely as there are large cracks, (previously filled), that have reopened. Consider sealcoating of the lot after cracks have been repaired and filled.

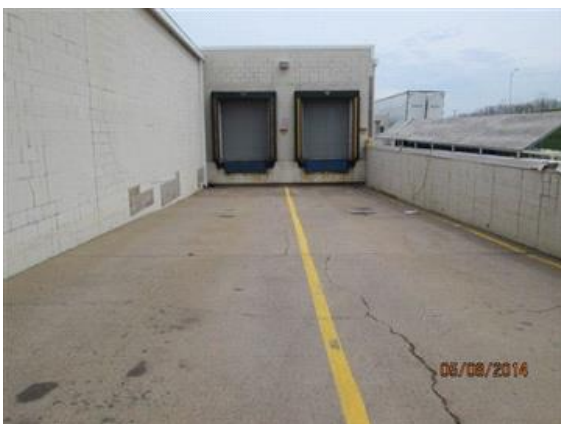
Dock area retaining wall top cap is damaged in at least three places and water can get in under the cap. The railing anchor bolts on this wall are rusting and are at risk of failing.

Truck dock area.

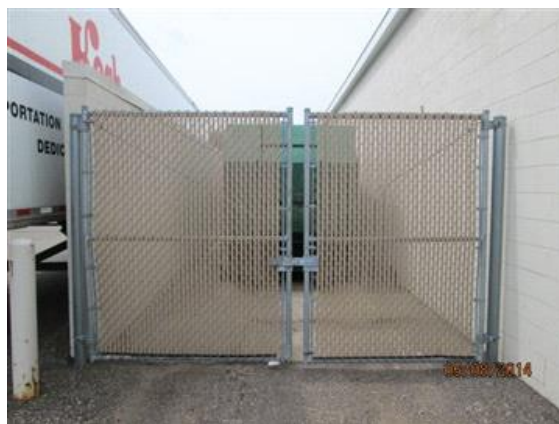
Fenced area for recycling compactor.

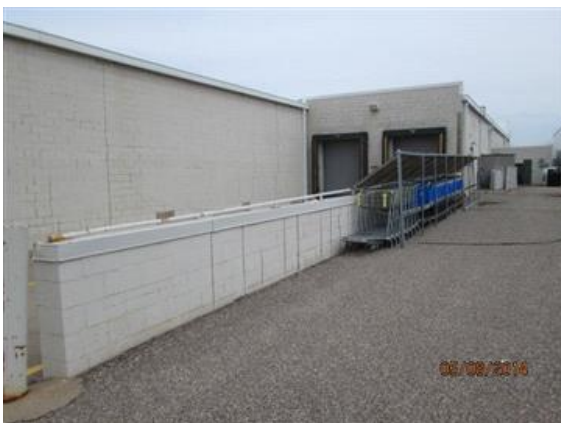
Dock area retaining wall.

Repair grass areas that have died due to "drive over" at curb as well as repair retaining wall top cap where damaged.

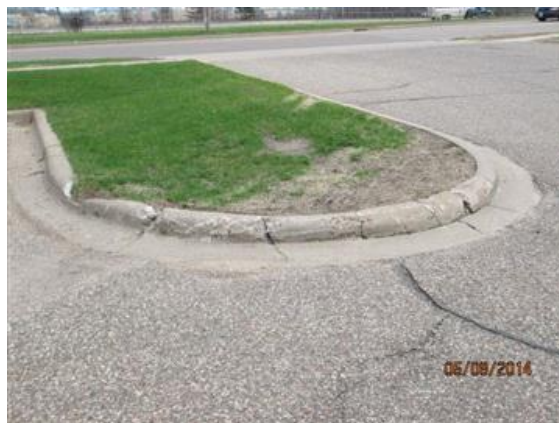
Curbing at southeast driveway. Note the 'drive over' area of dead grass.

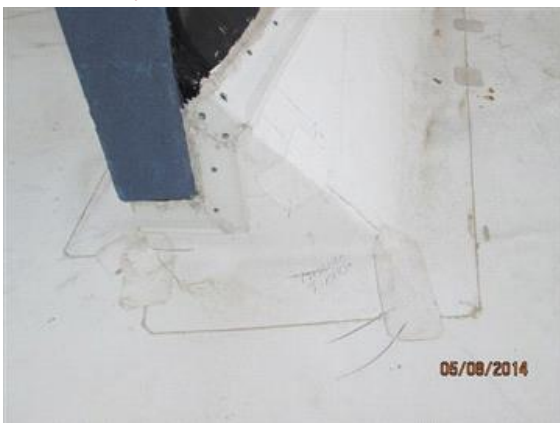
Membrane flashing at parapet wall.

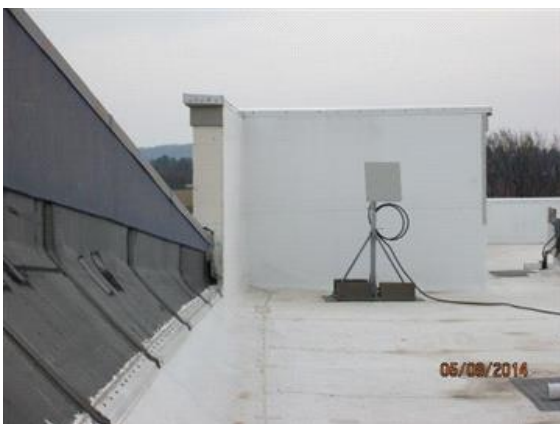
View across the north face looking east.

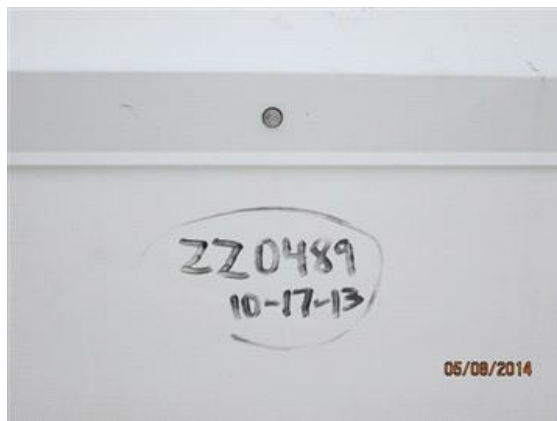
Roof service completion date of October 2013 and parapet wall top cap.

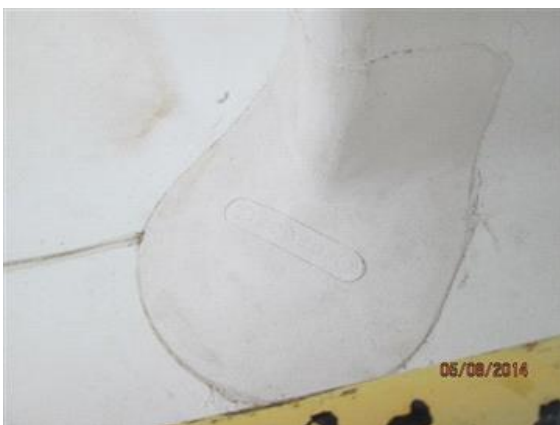
Membrane roof joint. Typical, in good condition.

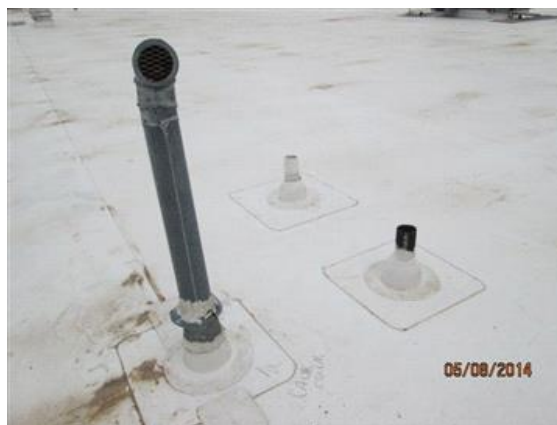
Typical roof penetrations.

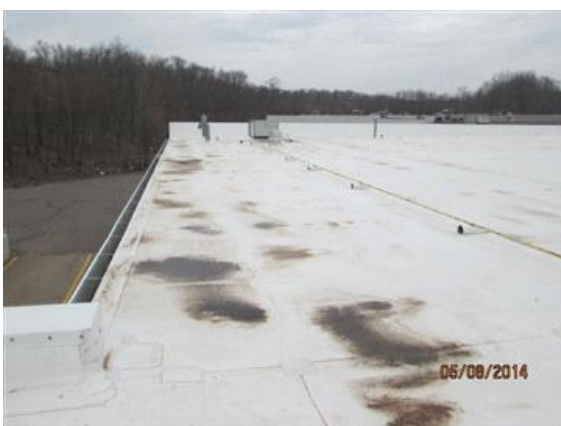
View of the roof's south edge looking west. Gutter is to the left side.

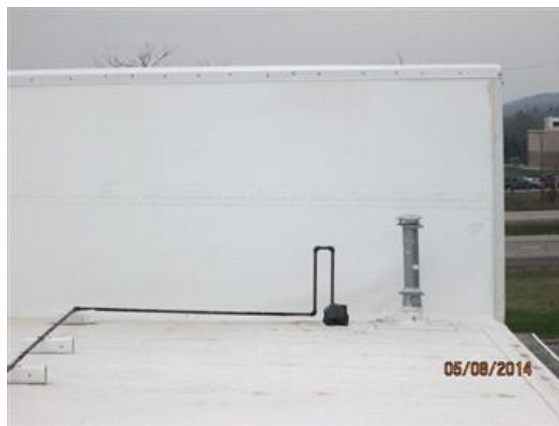
Parapet wall looking east - gutter to the right side of photo.

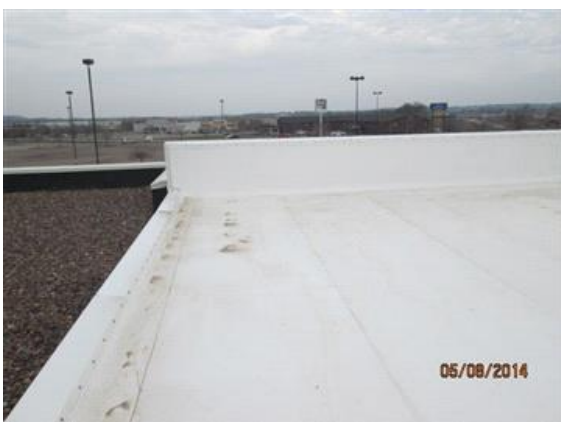
Parapet wall looking north along the west side next to adjacent roof area to another store.

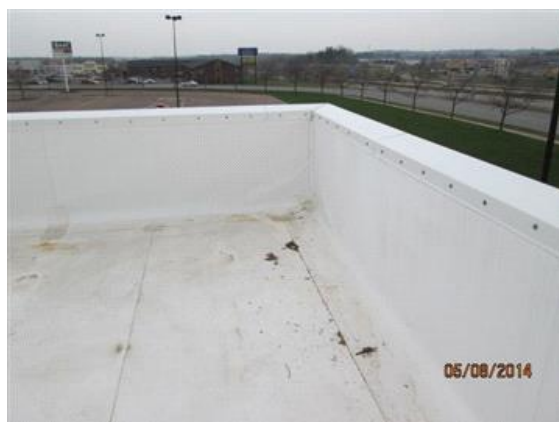
Parapet walls in northeast corner of roof.

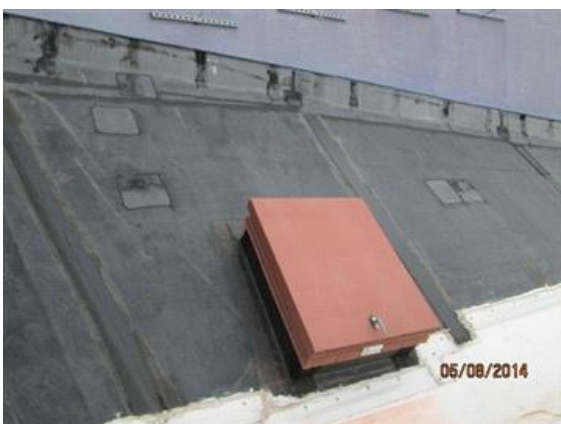
Hatchway into larger and higher parapet section.

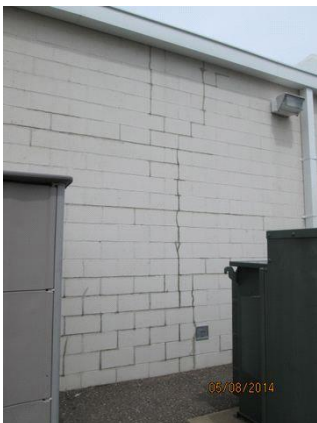
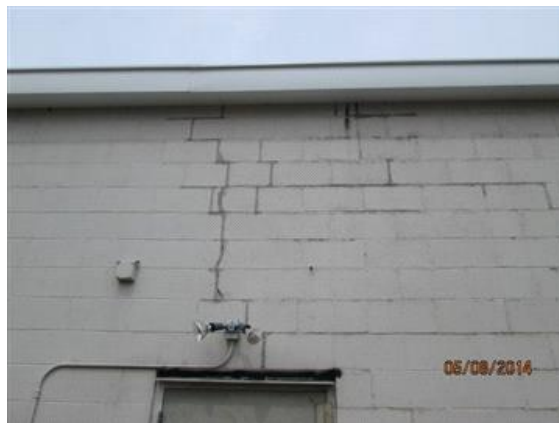
The decorative concrete block at the north and east sides of the building have some areas of cracking due to settling. Seal cracks and make repairs as necessary and monitor for any further movement. Where block mortar joints have cracked and been filled, the repairs are very visible and the wall is in need of painting.

Block wall with visible joints.

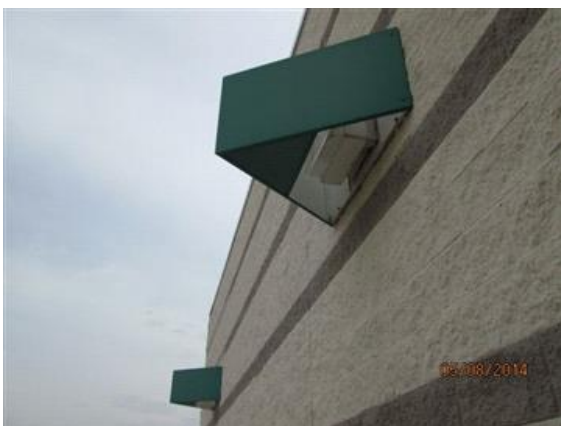
Wall mounted lighting at the front of the building.

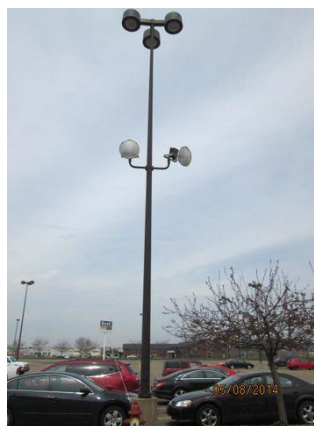
Pole mounted lighting in the parking lot.

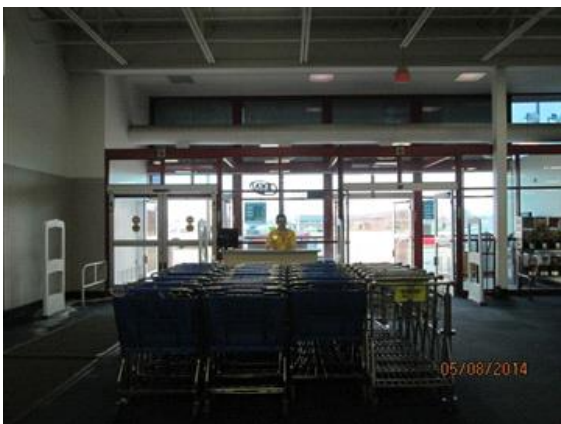
The only windows are located at the front entrance door. They are in good condition.

View of windows from the inside of the building.

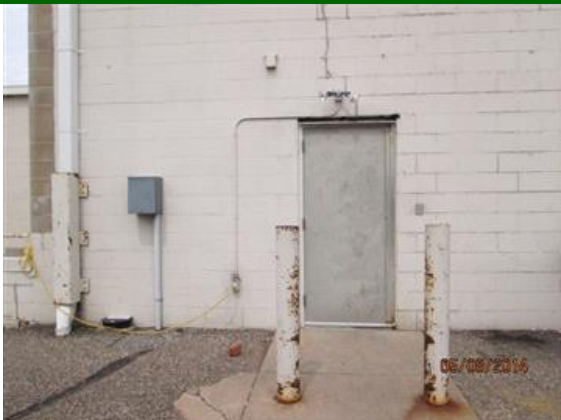
Main service door at shipping and receiving area.

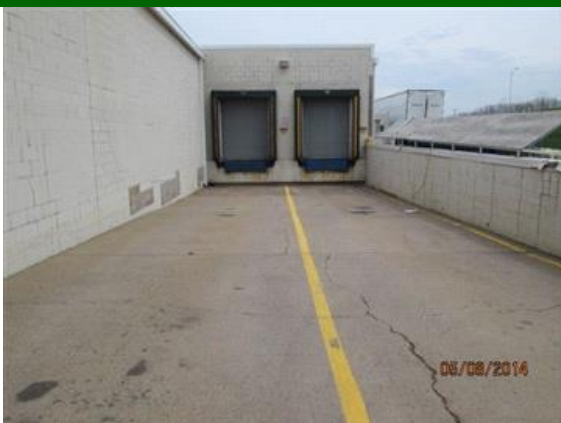
Dock area - service doors.

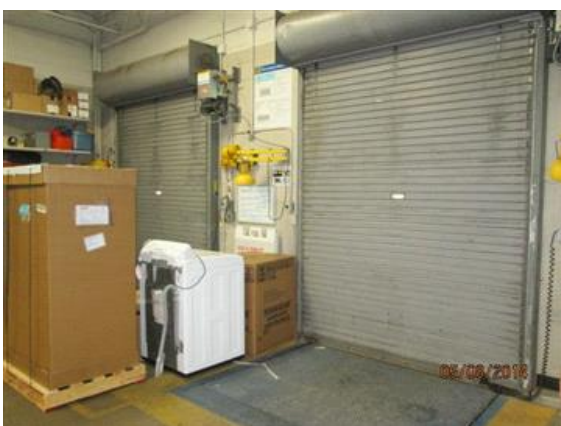
Dock area freight overhead door.

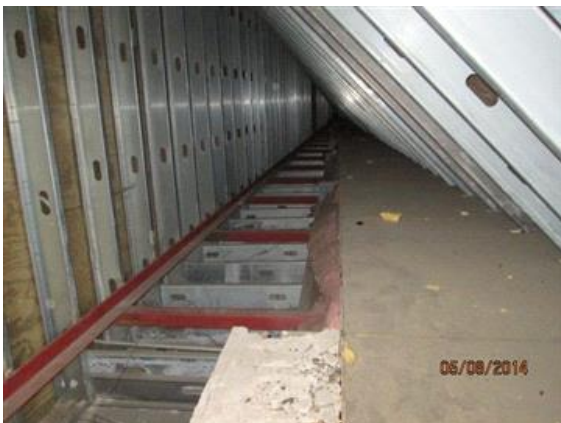
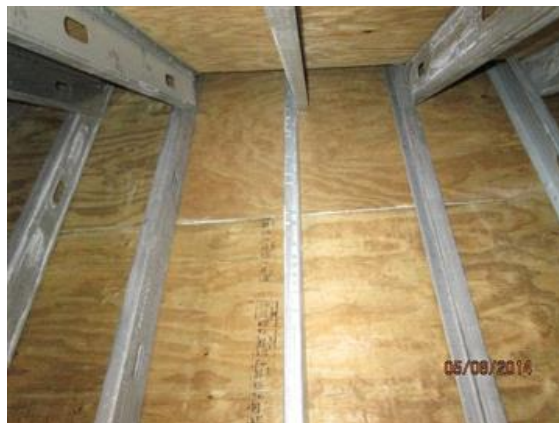
The roof structure is in good condition. The higher parapet wall is framed with metal studs and plywood.

Framing of front parapet wall - metal studs and plywood.

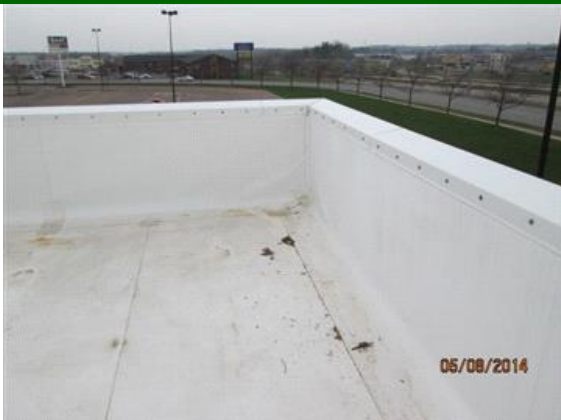
General view of roof at corner.

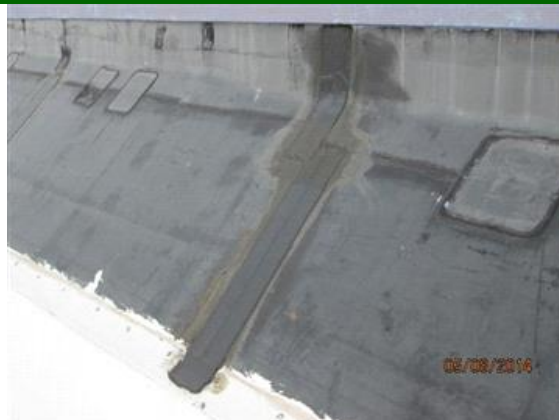
Backside of main parapet wall at north side.

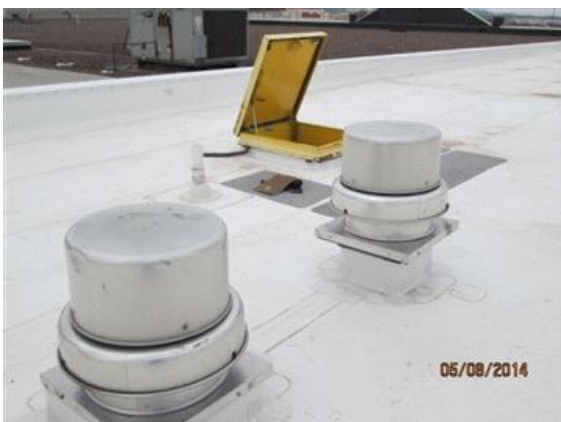
General view of roof looking south.

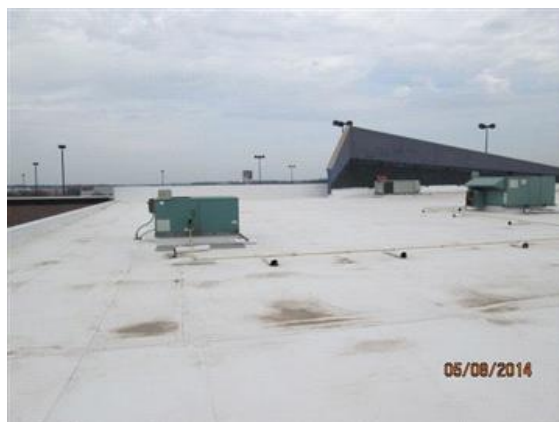
General view of roof looking north.

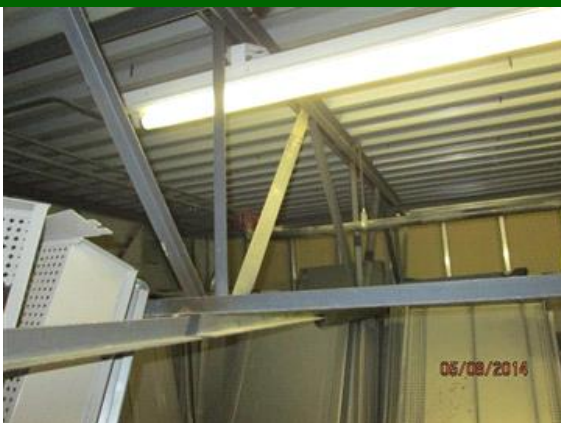
Detail of joist and decking.

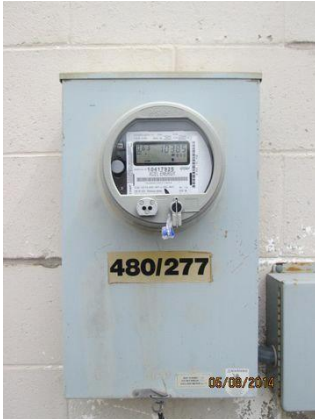
Electric meter located on south exterior wall near transformer.

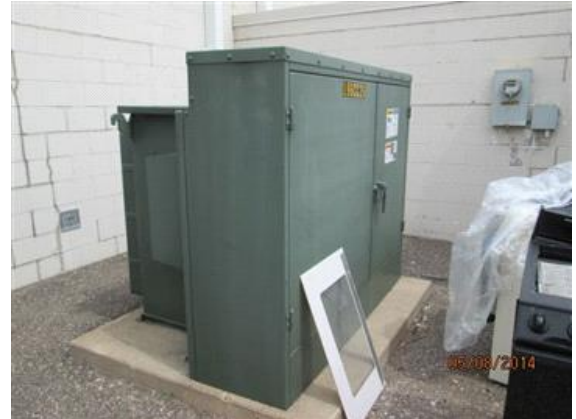
South side transformer and meter.

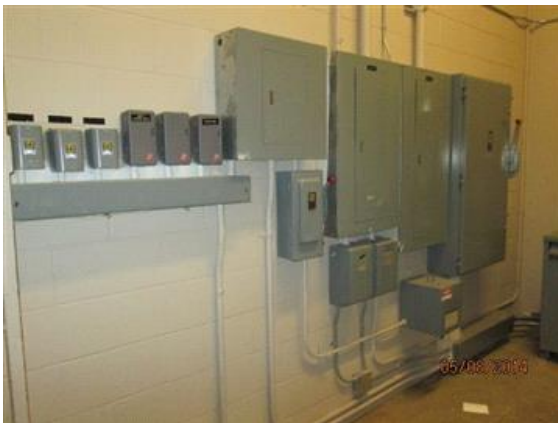
Secondary electrical distribution room.

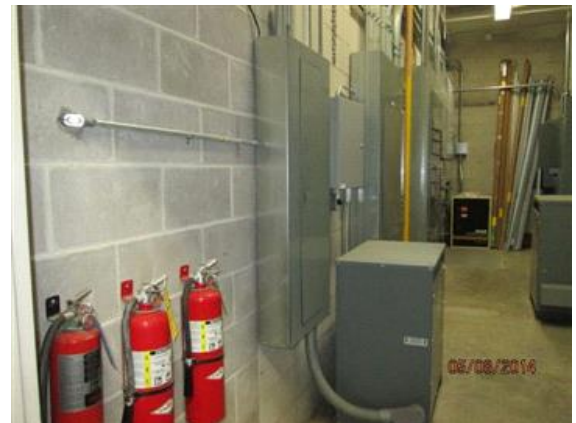
Main electrical service room with panels and main disconnect.

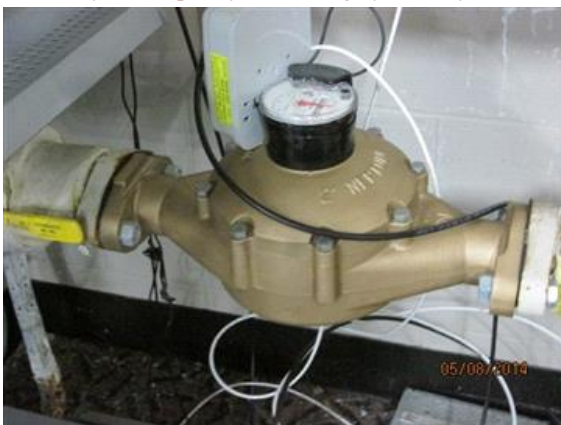
Water service meter located near the fire protection riser in closet off of retail floor.

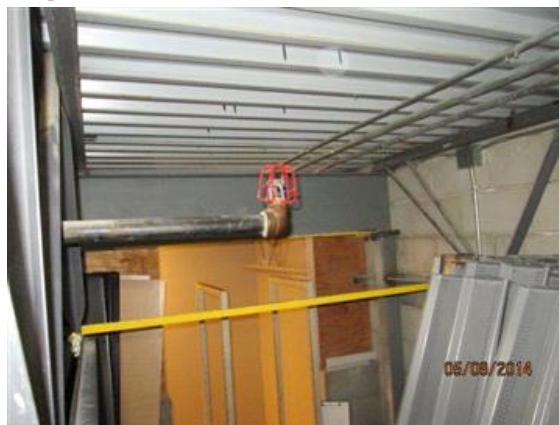
Fire protection system at roof metal decking.

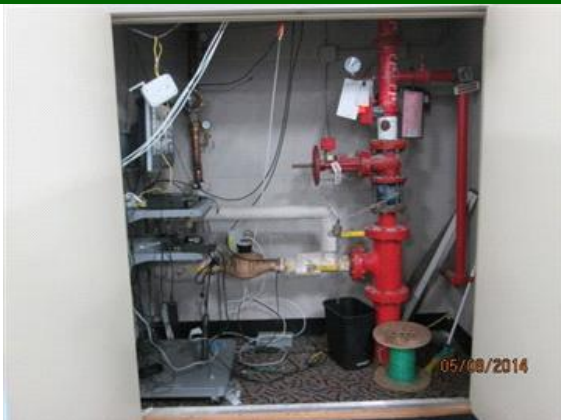
Fire protection and water service closet.

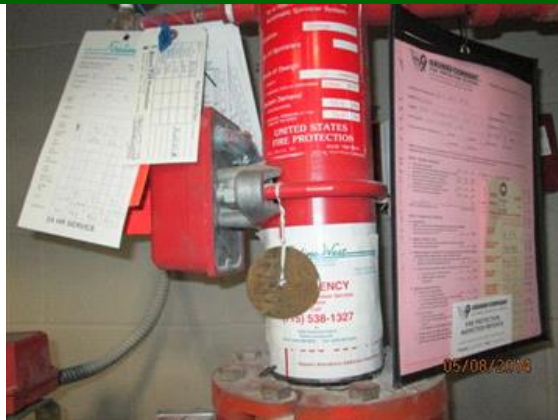
Fire protection service tags and records. All up to date.

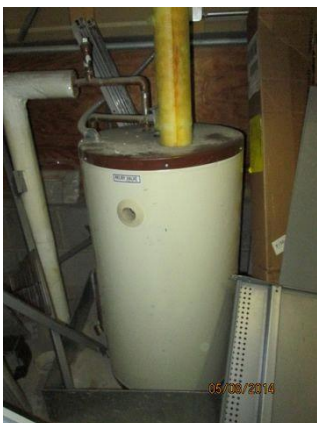
There is an approx. 20 gallon electric water heater located in the ceiling space above the restrooms. Access to the water heater was limited in the ceiling space due to stored materials in the way of reaching the unit.

Water heater above ceiling space.

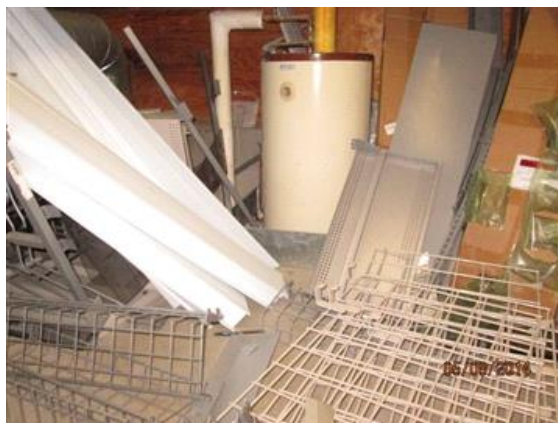
Access to water heater above ceiling space was blocked by stored materials.

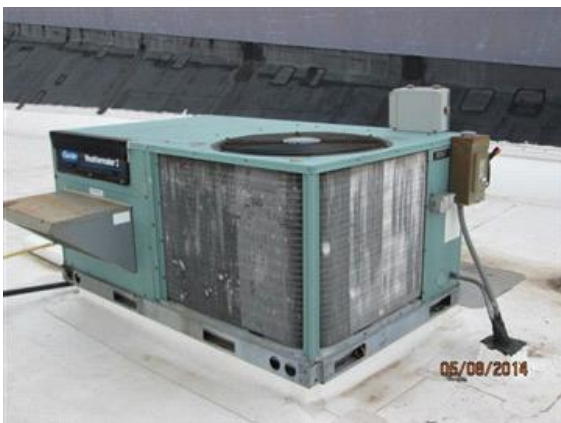
There are 6 Trane RTU's that are 17 years old.

Trane RTU unit.

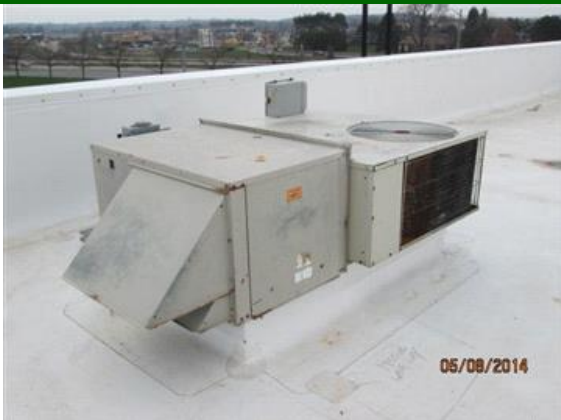
Smaller Carrier unit.

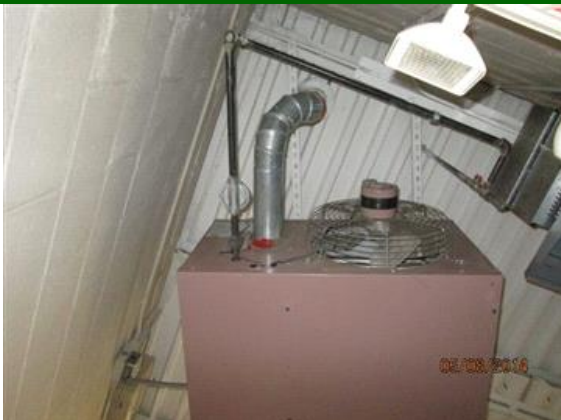
Gas fired unit heater ventilation through roof.

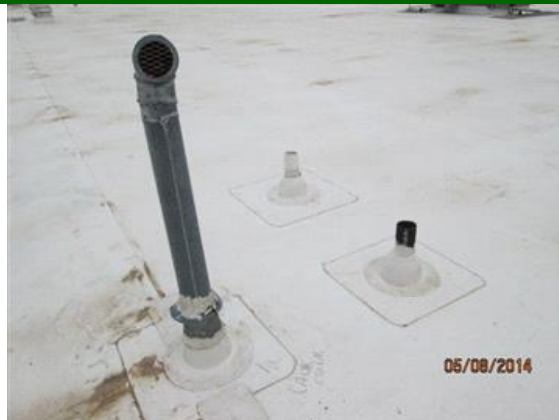
Typical roof penetrations.

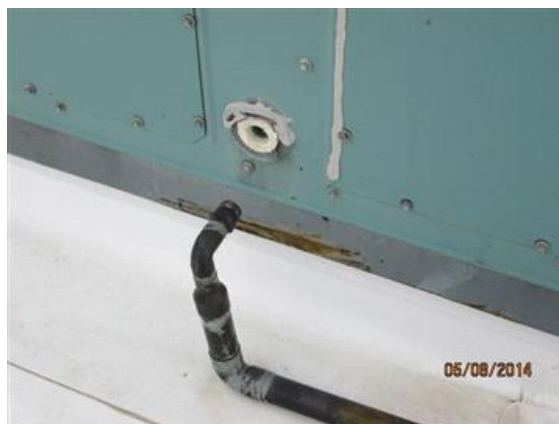
RTU - 7 condensate line is disconnected from unit.

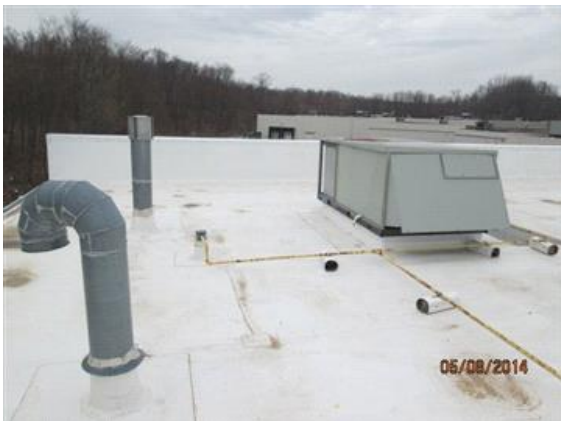
Roof Top Unit and exhaust venting.

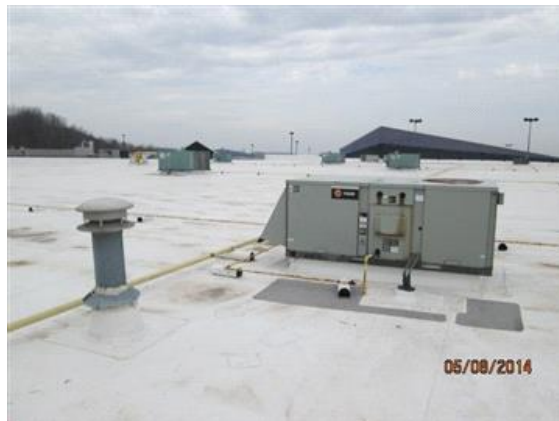
Roof Top Unit and exhaust wiring.

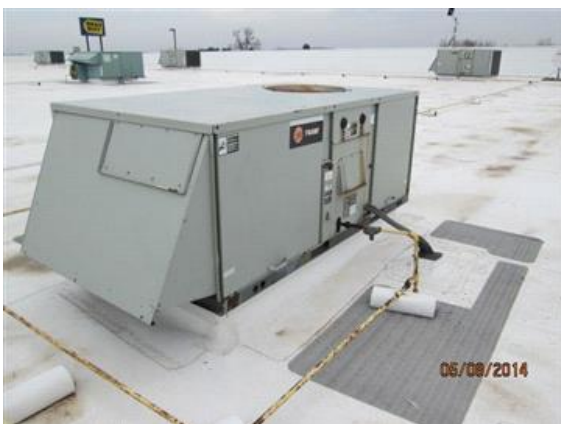
Roof Top Unit - Typical discharge directly into the space below with minimal distribution.

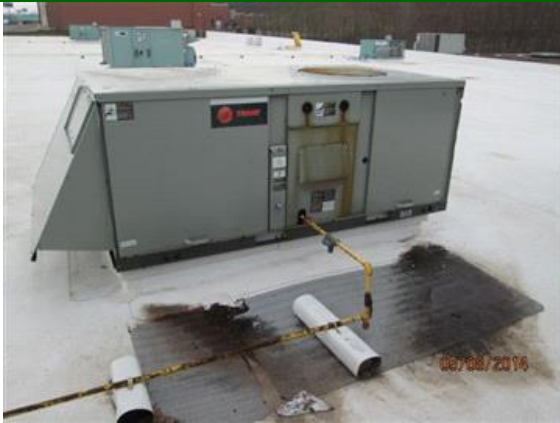
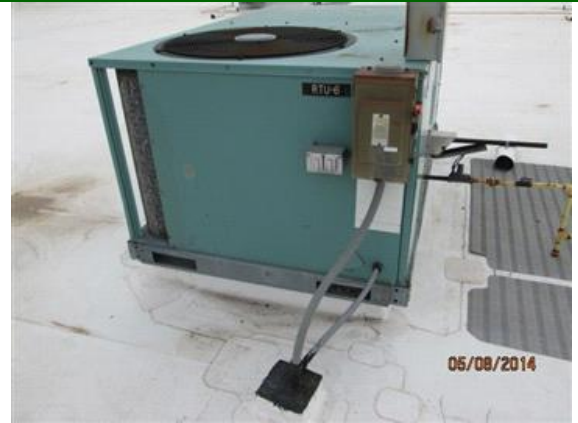
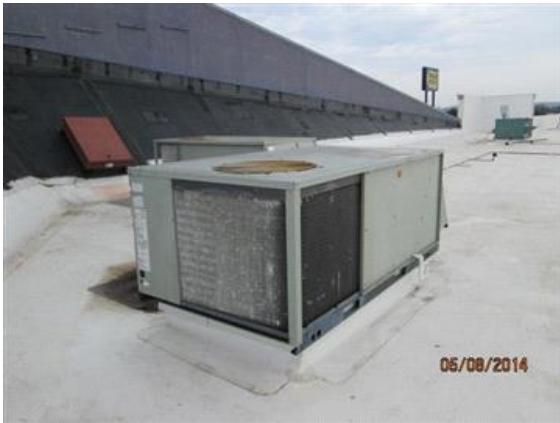
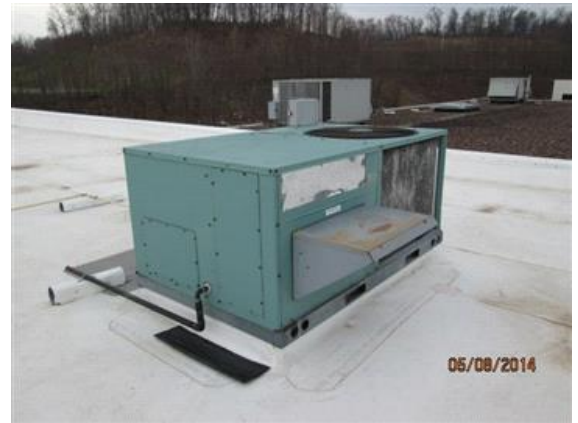
Roof Top Unit accommodates both heating and cooling.

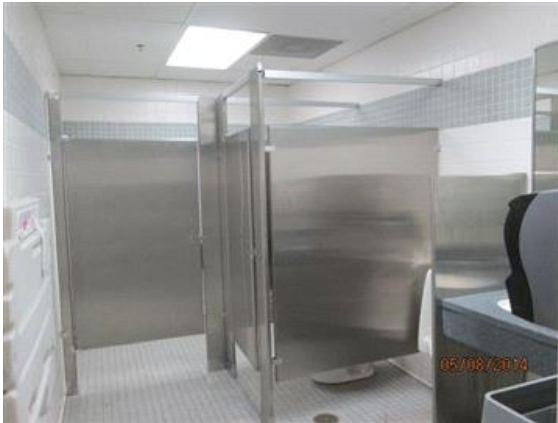
All restrooms were in good condition.

Men's restroom.

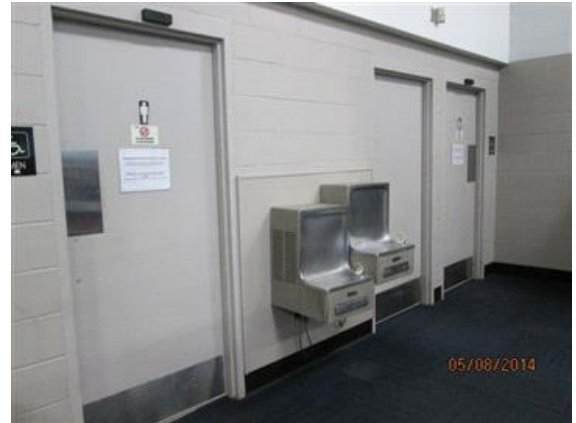
View of restroom entrance doors.

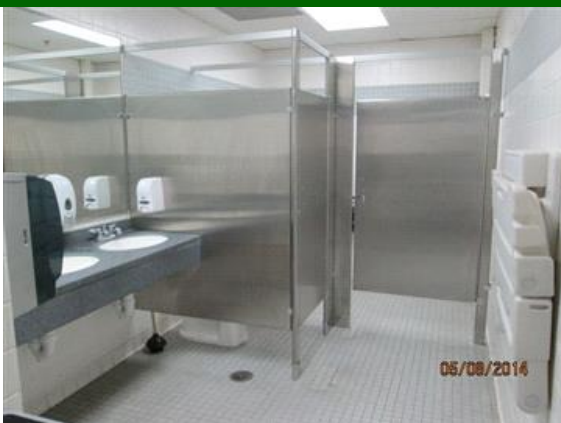
Women's restroom.

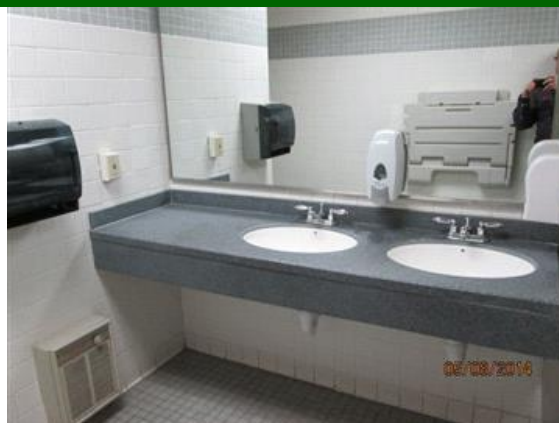
Women's restroom vanity.

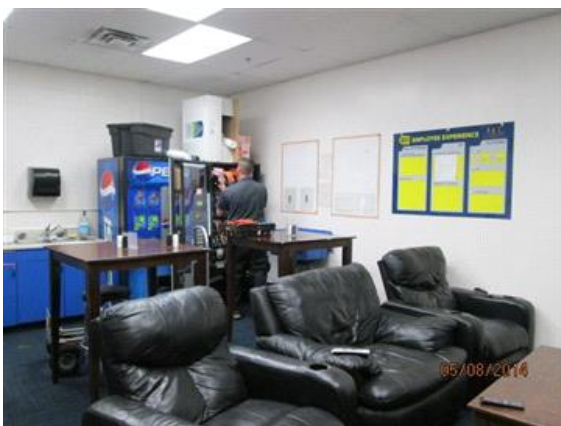
Employee lounge and breakroom

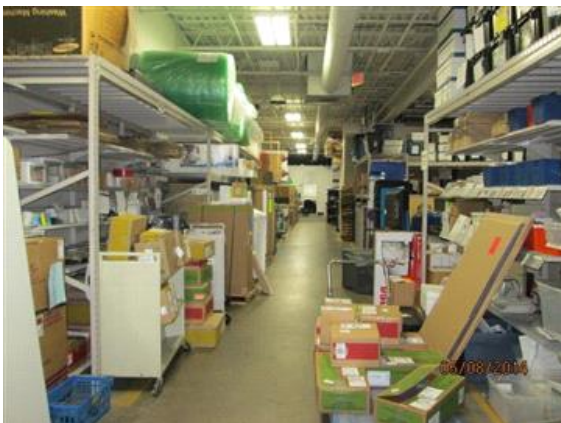
Storage area off of warehouse space.

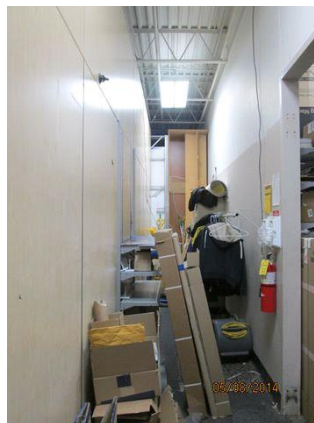
Back area of display space being used for storage.

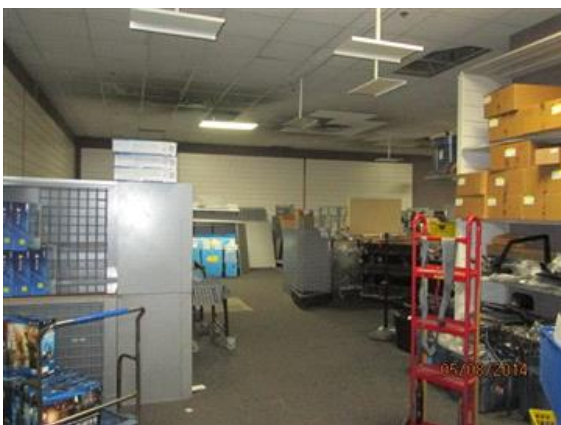
Former retail space being used for storage.

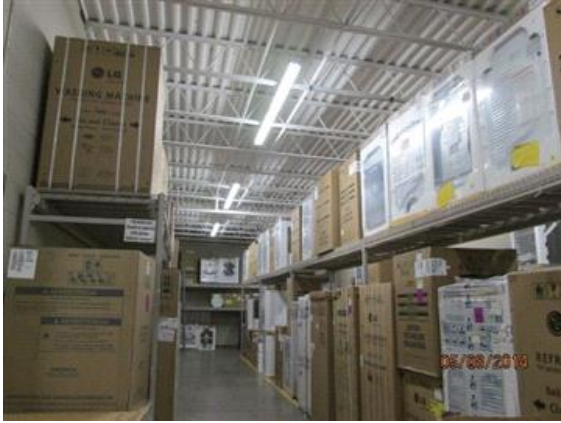
Warehouse rack storage.

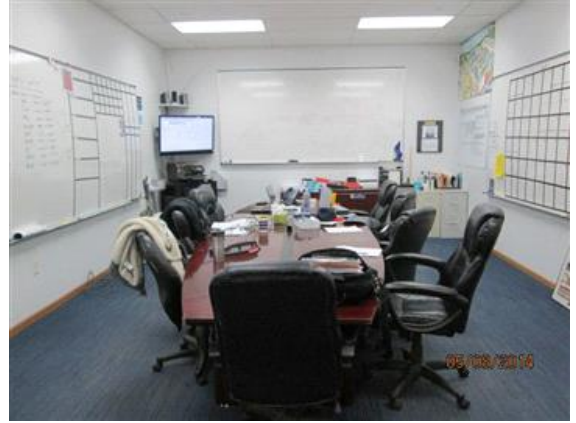
Warehouse meeting room.

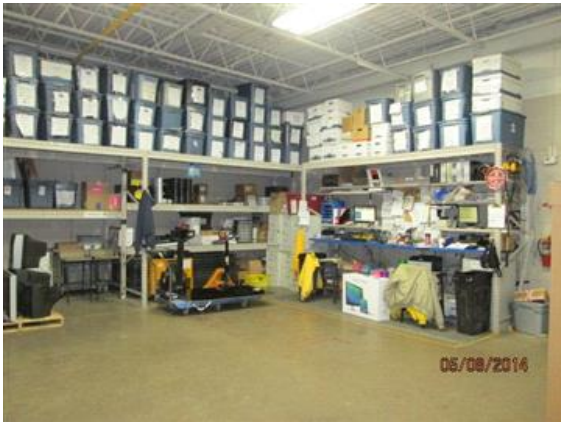
Shipping/receiving area next to dock doors.
